**DEPARTMENT OF TRANSPORTATION****DIVISION OF ENGINEERING SERVICES**

Contract #: 04-0120F4Cty: SF/ALA Rte: 80 PM: 13.2/13.9File #: 69.28**WELDING INSPECTION REPORT****Resident Engineer:** Pursell, Gary**Address:** 333 Burma Road**City:** Oakland, CA 94607**Report No:** WIR-003947**Date Inspected:** 25-Sep-2008**Project Name:** SAS Superstructure**OSM Arrival Time:** 2230**Prime Contractor:** American Bridge/Fluor Enterprises, a JV**OSM Departure Time:** 730**Contractor:** Zhenhua Port Machinery Company, Ltd (ZPMC), Changxing Island **Location:** Shanghai, China**CWI Name:** Chen Xi**CWI Present:** Yes No**Inspected CWI report:** Yes No N/A**Rod Oven in Use:** Yes No N/A**Electrode to specification:** Yes No N/A**Weld Procedures Followed:** Yes No N/A**Qualified Welders:** Yes No N/A**Verified Joint Fit-up:** Yes No N/A**Approved Drawings:** Yes No N/A**Approved WPS:** Yes No N/A**Delayed / Cancelled:** Yes No N/A**Bridge No:** 34-0006**Component:** OBG-PMT**Summary of Items Observed:**

# WELDING INSPECTION REPORT

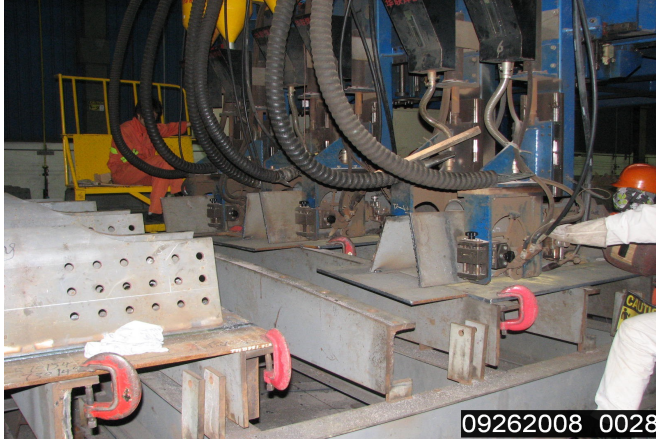
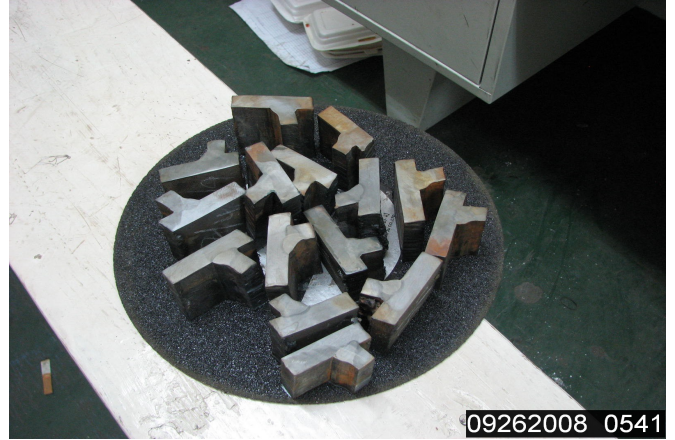
Bay 1: Caltrans QA inspector monitored OBG Production Monitoring Test (PMT) for deck panel DP227-001. The magnetic particle test (MT) of the tack welds was performed by ZPMC QC/MT inspector. The visual inspection of tack welds and root gap was performed by ABF, ZPMC and Caltrans. The start time for welding of the PMT is 00:31 hours and completion time 01:04, 09-26-08. Caltrans QA inspector verified and documented the welding amperage, voltage and travel speed during the gas metal arc welding (GMAW) and submerged arc welding (SAW) process, welds 1 thru 6. At the completion of the GMAW root pass and SAW cover pass. The welds were visually inspected by ABF, ZPMC and Caltrans. Caltrans QA inspector witness ZPMC QC/UT inspector identified as Xue Hai Yong inspect the welds for depth of penetration and conformance. Caltrans QA inspector identified designated locations for macro sampling per contract requirements. The macroetch samples were evaluated with a 7X optical comparator and accepted by ZPMC, ABF and Caltrans. See Caltrans U-ribs PMT Inspection Sheet, dated 09-26-08 and ZPMC production monitoring test plate inspection report, dated 09-26-2008 for additional information. The following picture illustrates welding of the PMT and typical macroetch specimens.
